# **Palisades Subbasin Total Maximum Daily Loads**

2013 Addendum and Five-Year Review

**State of Idaho  
Department of Environmental Quality**

**November 2013**

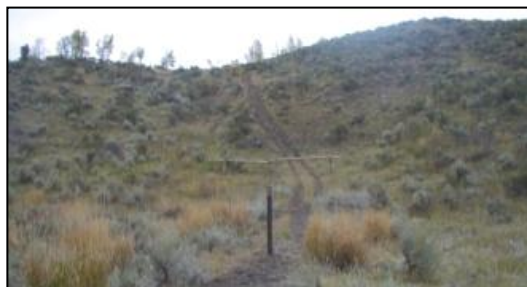
**South Fork Fall Creek Trail Closure:** The Forest closed 1 mile of user-created motorized trail using signs and barricades (Figure 6). Water bars and drainage features were installed on closed trails to reduce erosion.

**Figure 6.**  
**South Fork Fall Creek Trail closure.**

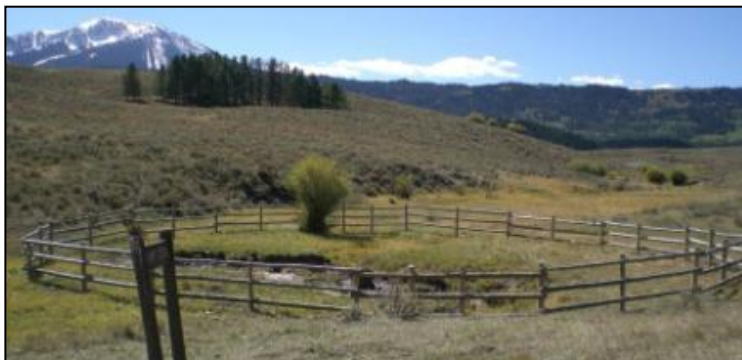
**Camp Creek Fence:** The Forest built a small enclosure around a problem area on Camp Creek to improve streambank stability (Figure 7). Camp Creek is a small tributary to McCoy Creek. Heavy use by wildlife and livestock had degraded the streambanks.

**Figure 7.**  
**Camp Creek enclosure.**

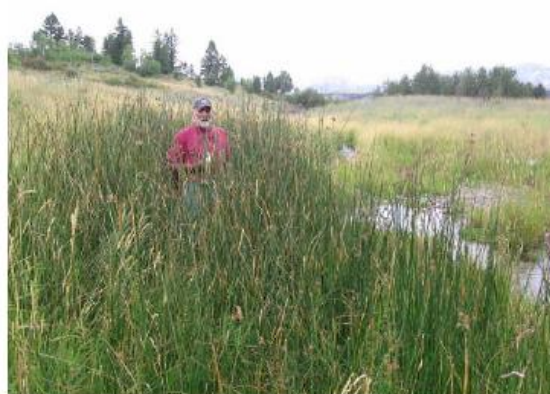
**Figure 8. Matt Woodard, TU home rivers initiative coordinator, stands in natural wetland vegetation along the restoration reach of Pritchard Creek.**

**Pritchard Creek:** In 2003, the Forest Fisheries Program and TU removed an old irrigation dam, converted the pond bed to a meadow, and restored the stream channel in Pritchard Creek, a tributary to the South Fork Snake River. Cattle were excluded from the project area and water was provided upslope with a solar pump and trough system. The results of ongoing effectiveness monitoring continue to show improvements. In addition to the vegetation that was planted along the stream and in the uplands, native vegetation is naturally re-establishing along the stream (Figure 8). Bulrush and coyote willow are particularly noticeable. The stream channel continues to develop new floodplains, establish gravel beds, and retain less fine sediment, benefiting this Yellowstone cutthroat trout stronghold stream.

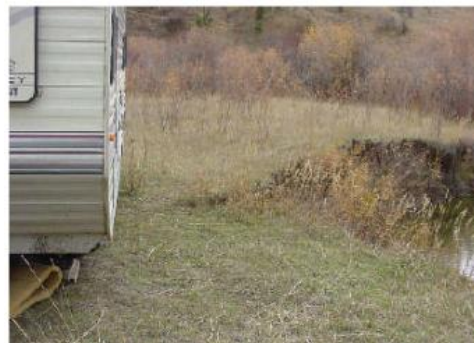
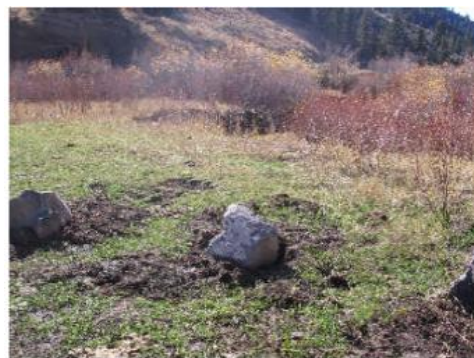
During summer 2006, boulders were strategically placed around and gravel was placed on areas acceptable for motorized vehicle and camp trailer parking. This project should decrease erosion and sediment delivery to Fall Creek and benefit important riparian vegetation. It compliments previous work to better manage cattle use along upper Fall Creek with fencing and water developments. The decrease in sedimentation and stream channel improvements are expected to benefit Yellowstone cutthroat trout that inhabit the stream.

**Figure 9. A trailer parked extremely close to Fall Creek at a dispersed recreation site in 2005 (top) is an example of a typical encroachment. The placement of boulders at the site in 2006 (bottom) is expected to eliminate this type of impact to the streambanks and vegetation.**

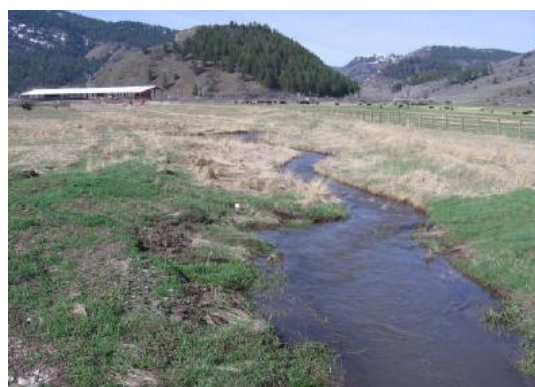
**Figure 10. Garden Creek flows in its new channel through Conant Valley Ranch during spring 2006.**

**Conant Valley Ranch:** In spring 2006, flow was restored to the historic channel of Garden Creek through Conant Valley Ranch, reconnecting an isolated Yellowstone cutthroat trout population upstream on the Forest with the South Fork Snake River (Figure 10). Effectiveness monitoring during the spawning season identified large Yellowstone cutthroat trout from the river spawning in upper Garden Creek, indicating they have found their way back into the stream from the South Fork. Fall effectiveness monitoring found the new Conant Valley Ranch segment of Garden Creek seeded with several age classes of Yellowstone cutthroat trout (probably from upstream). No rainbow trout were observed, but 1-year-old brown trout were collected in a backwater area at the mouth of the stream. Annual monitoring will continue.

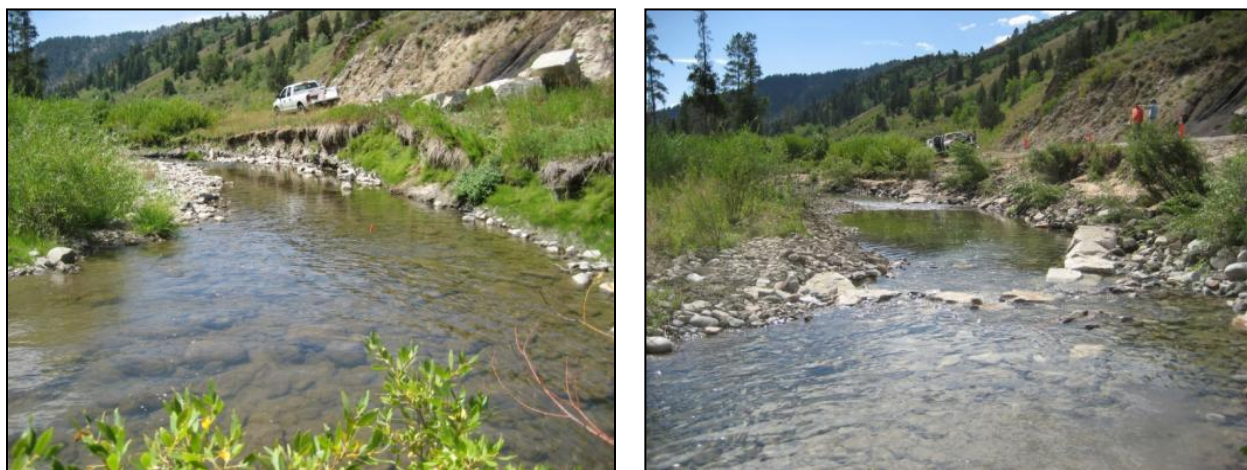
**Highway 31 Protection and Pine-North Pine Creeks Stabilization:** The project was located near the confluence of North Fork Pine and Pine Creeks along State Highway 31. The Forest partnered with the Idaho Transportation Department to stabilize nearly 300 feet of eroding banks while protecting the highway and public safety. Streambank erosion was threatening the highway bridge on North Fork Pine Creek and another portion of Hwy 31 along Pine Creek. The project involved constructing boulder vane-type structures (two “J-hooks” and one cross-vane), rebuilding streambanks, and transplanting willows to provide long-term bank stability (Figure 11).

**Figure 11. Before (left)—Pine Creek’s eroding bank within 15 feet of Highway 31. After (right)—J-hook vanes and 3–4 feet of constructed streambank.**

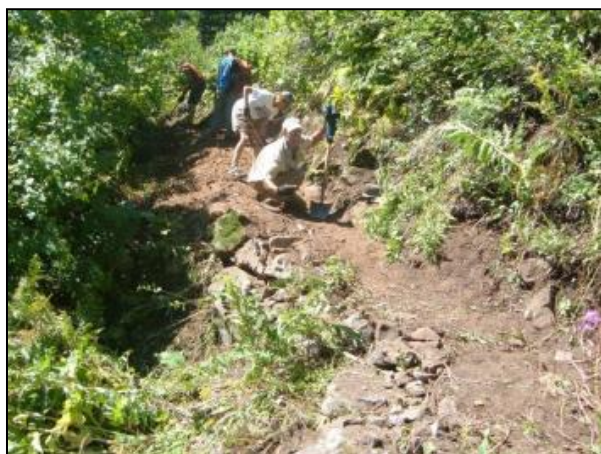
**Red Creek Trail Reroute:** Building on the work done in 2007, the Teton Basin Trail Crew and Teton Valley Trails and Pathways combined efforts to construct a 0.5-mile reroute on Red Creek in the Big Holes Range (Figure 12). The reroute eliminated two creek crossings on the Red Creek Trail (#241).

**Figure 12.**  
**Red Creek Trail reroute.**

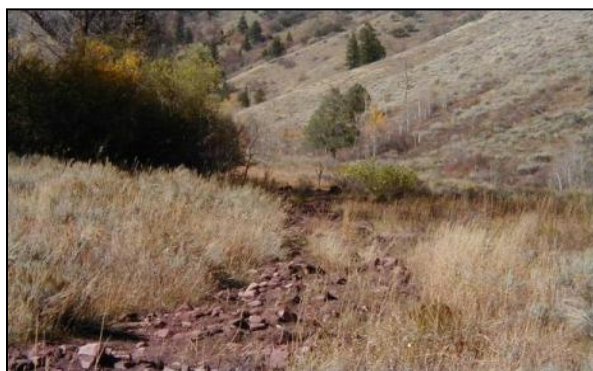
**Bear Creek Road Closures:** The Forest partnered with Bonneville County to close several user-created spur roads (approximately 1 mile) off Bear Creek Road (058). Some roads accessed Bear Creek and Palisades Reservoir, while others accessed dispersed camp sites. The spurs were ripped and boulders placed to restrict access (Figure 13 and Figure 14).

**Figure 13.** Road in Red Spring Draw that was ripped and closed.

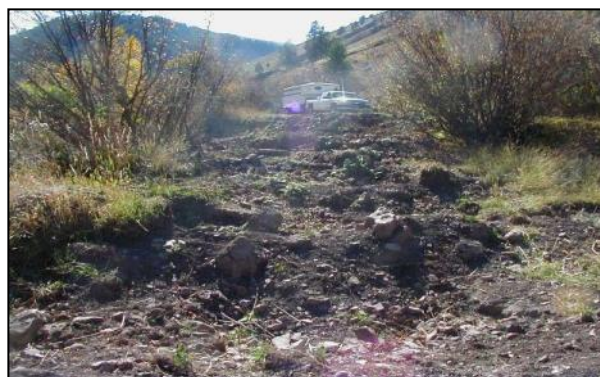
**Figure 14.** Road near Bear Creek/Palisades Reservoir that was closed.

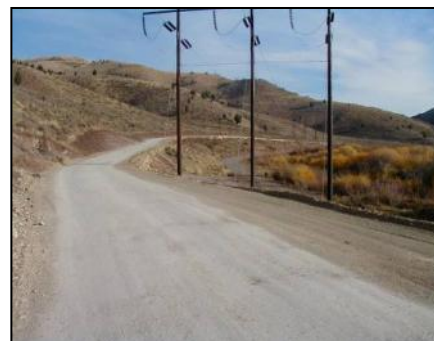
**Fall Creek Road Reroute:** The Forest and Bonneville Power partnered to relocate a portion of Fall Creek Road (077) from the riparian bottom to an upland site (Figure 15).

**Figure 15.**  
Old road on right side of photo near creek bottom was closed off on each end.

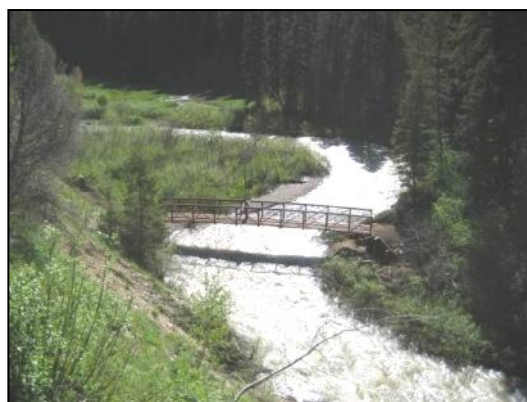
**Palisades Creek Trail Bridge:** A new trail bridge was installed on Palisades Lake Trail (#112) (Figure 16). This bridge will provide passage for livestock and hikers. The bridge was constructed by a contractor. Bridge material was flown in by helicopter and tools and labor were transported by livestock.

**Figure 16.**  
A new trail bridge replaced the eroding ford crossing.

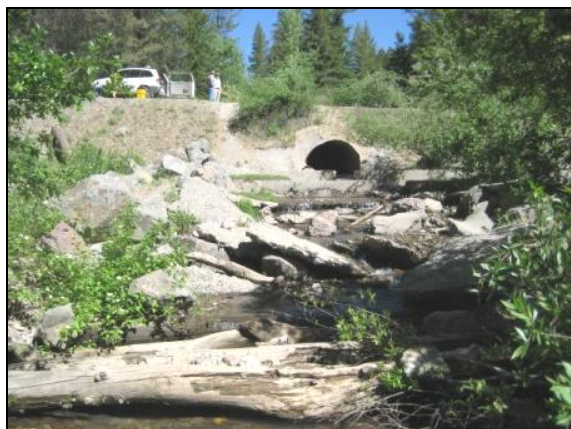
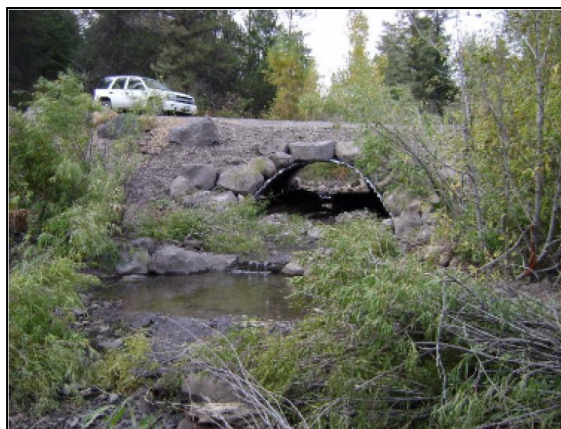
**Table Rock Culvert and Trail Closure:** TU and the Forest partnered on this project to restore upstream migration for Yellowstone cutthroat trout and stream hydrology on Table Rock Creek (a tributary to the South Fork Snake River). An impassable, under-sized culvert on Forest Service Road 217 was replaced with a bottomless arch (Figure 17). In addition, two illegal all-terrain vehicle (ATV) trails were closed. The riparian area upstream and downstream of the road crossing was recontoured and planted with native vegetation.

Figure 17. Table Rock culvert before (left) and after (right).

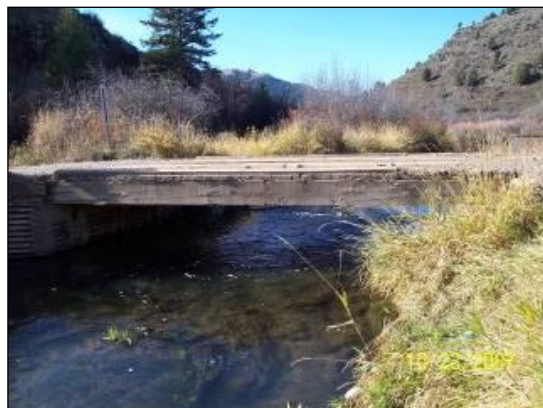
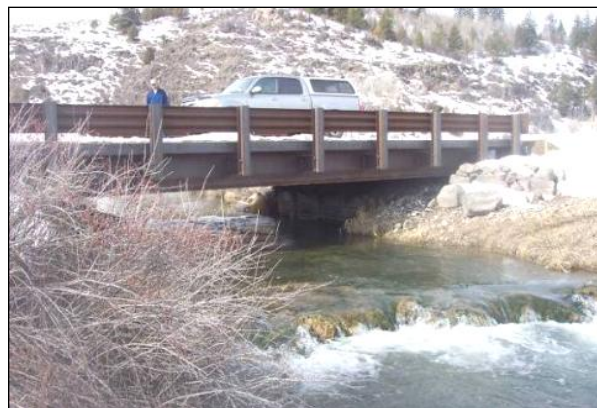
**Fall Creek Bridge:** The Forest and Bonneville County replaced a narrow bridge with a larger structure on River Road (076) (Figure 18).

Figure 18. Fall Creek: Original bridge looking upstream (left) and new bridge looking upstream (right).

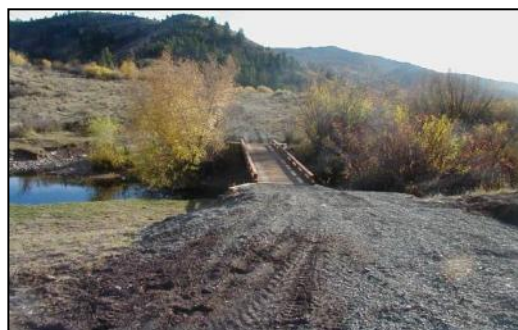
**Horse Creek Trail Bridge:** The Idaho Falls Trail Machine Association and IDPR partnered with the Forest to install a bridge on Fall Creek that replaced an eroding stream ford on the Horse Creek Trail (#140) (Figure 19).

Figure 19.  
Horse Creek Trail Bridge.

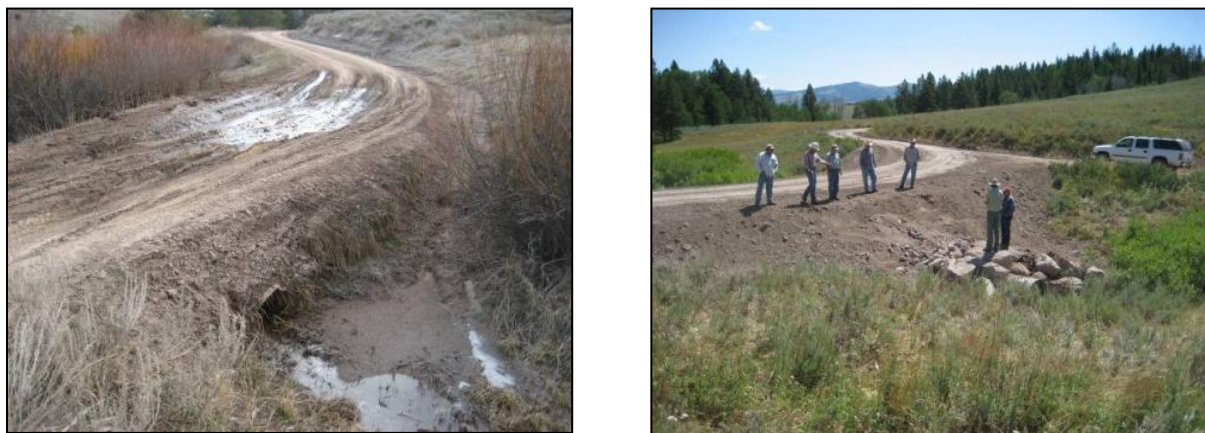
**Brockman Major Road Improvement:** The project involved graveling and improving drainage along approximately 6 miles of Brockman Road (077) within the McCoy Creek drainage (Figure 20). The road is located in an area of highly erodible soils. Repairing poor road drainage and adding surfacing on a natural surface road have greatly reduced sedimentation entering Clear Creek and its tributaries. By reducing sediment input to these streams, the project has helped improve the watershed, diversity of aquatic species, and trout spawning habitat and contributed to Yellowstone cutthroat trout conservation.

**Figure 20. Before (left)—road contributed excessive sediment to stream. After (right)—new crossing prior to placement of gravel surfacing.**

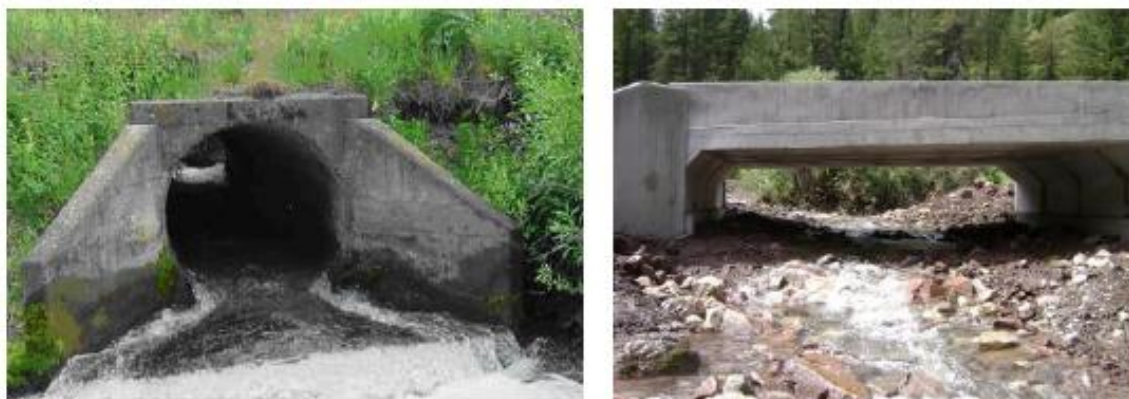
**Elk Creek Aquatic Organism Passage:** The Forest replaced a crossing of Elk Creek (Forest Service Road 058) in partnership with the Western Native Trout Initiative, USFWS, Eastern Idaho Resource Advisory Committee (RAC), and TU. The crossing was identified during the 2005 Forest culvert fish passage inventory as a barrier to Yellowstone cutthroat trout attempting to migrate up Elk Creek from Palisades Reservoir. It was replaced with a bridge that has appropriate flow capacity, width, and gradient, restoring access to more than 5 miles of quality habitat (Figure 21).

**Figure 21. Pre- (left) and post-construction (right) at Elk Creek crossing site, upstream of the Elk Creek/Bear Creek confluence. The impassable, under-capacity culvert was replaced with a bridge.**

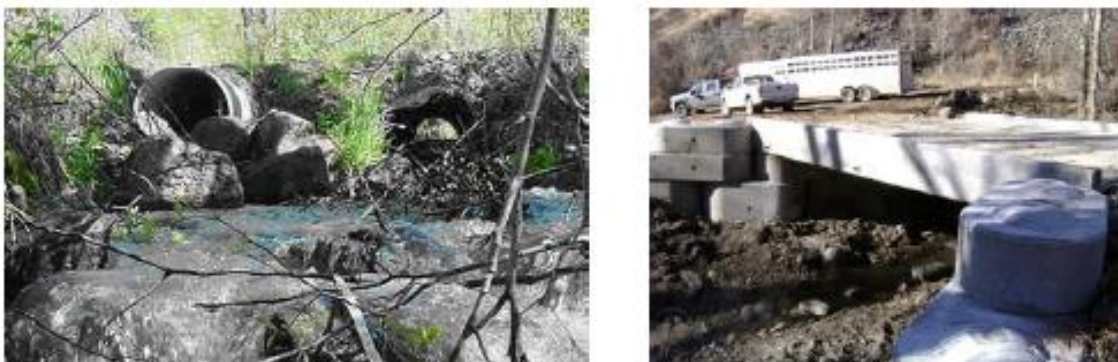
**Wolverine Creek Aquatic Organism Passage:** The Forest Fisheries Program worked in partnership with the RAC, USFWS, and TU to restore aquatic organism passage at Wolverine Creek at the South Fork Snake River Road (206). Wolverine Creek is a tributary to the South Fork Snake River with a resident population of Yellowstone cutthroat trout. The under-capacity, damaged culverts were replaced with a concrete component bridge (Figure 22).

**Figure 22. Pre- (left) and post-construction (right) at Wolverine Creek crossing site at the South Fork River Road. The impassable, damaged culverts were replaced with a concrete component bridge.**

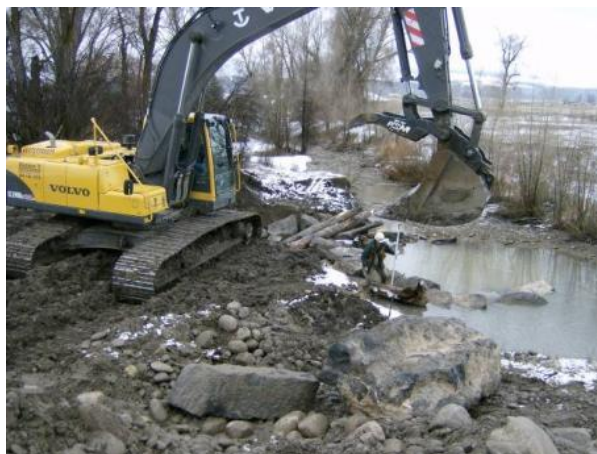
This project was downstream of the Forest boundary. The Forest assisted due to the importance of providing Yellowstone cutthroat trout passage upstream to the Forest and improving watershed condition for all owners. This project is one component of an overall goal to restore passage and eliminate fish entrainment on Rainey Creek so it can once again be one of the major spawning tributaries to the South Fork Snake River. The project focused on elevating the stream bed below a downcut Caboose Culvert outlet. In addition, three grade control rock structures were installed to ensure channel stability below the culvert. Wood revetment and bank shaping were performed to promote channel complexity and flood plain function and improve bank stability downstream (Figure 23, Figure 24, Figure 25, and Figure 26).

**Figure 23. Installing boulder grade control and wood revetment.**

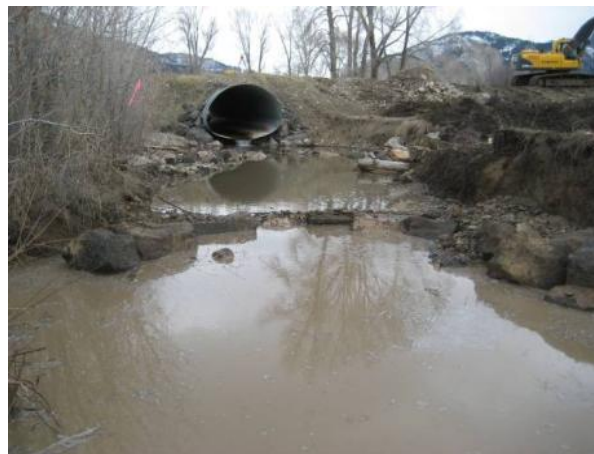
**Figure 24. Looking upstream at the outlet during construction.**

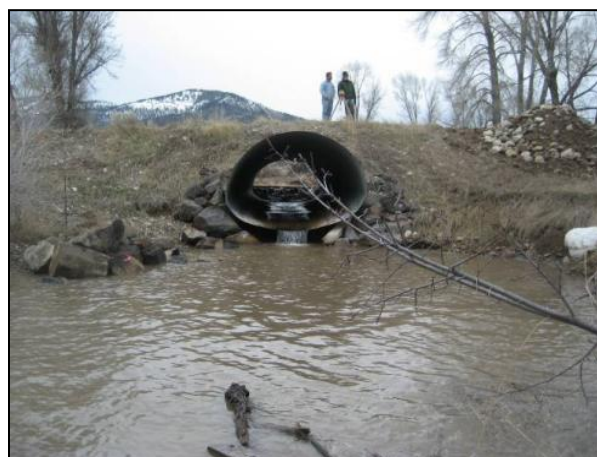
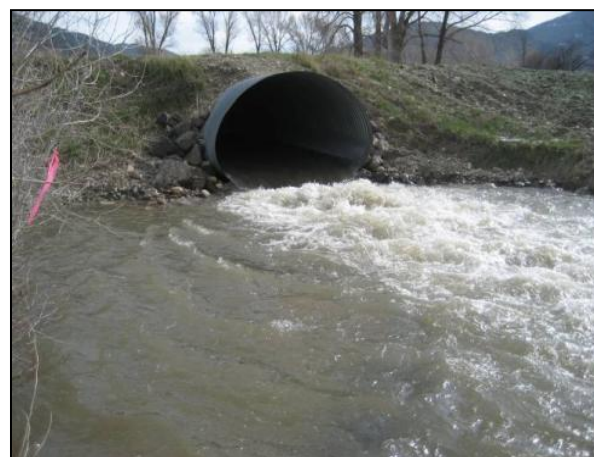
**Figure 25. Before (left): Looking upstream at culvert outlet and drop causing fish barrier. After (right): Looking upstream at culvert with grade control backing up flow into the culvert and eliminating the fish barrier. Picture taken at a bank-full event following construction.**

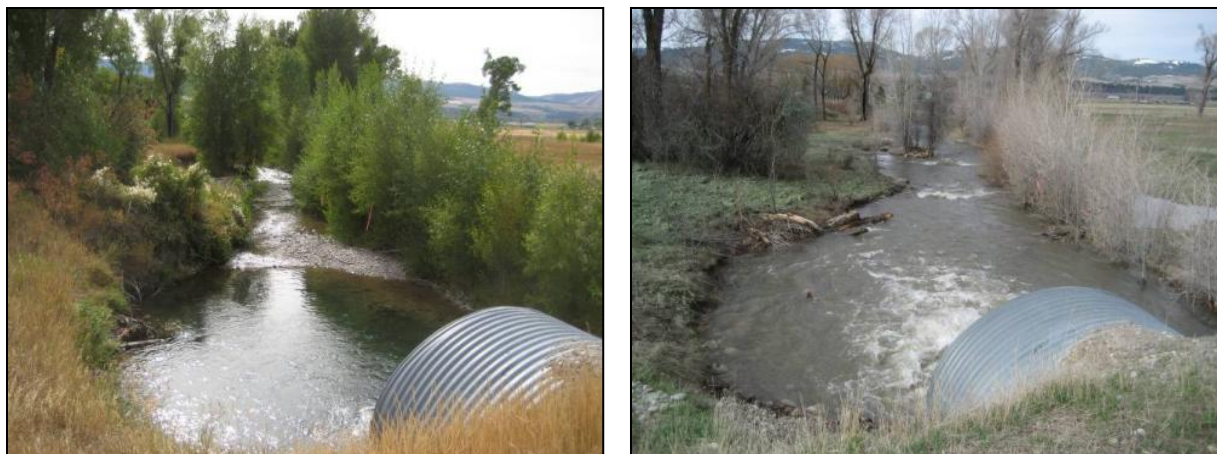
**Figure 26. Before (left): Looking downstream of culvert outlet. After (right): Looking downstream of culvert outlet with high bank on left-hand side removed to increase flood capacity. Photo taken during a bank-full event. The whitewater downstream shows the location of two grade control structures.**

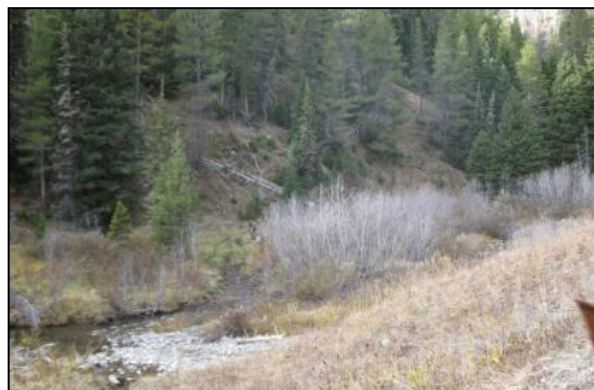
**North Fork Palisades Trail:** The trail was relocated to avoid wetland, stream, and landslide crossings (Figure 27). Additional water drainage features were installed to reduce erosion. The trail originally crossed the stream then passed through approximately 100 yards of wetland. This crossing was eliminated.

**Figure 27.  
North Fork Palisades Trail.**

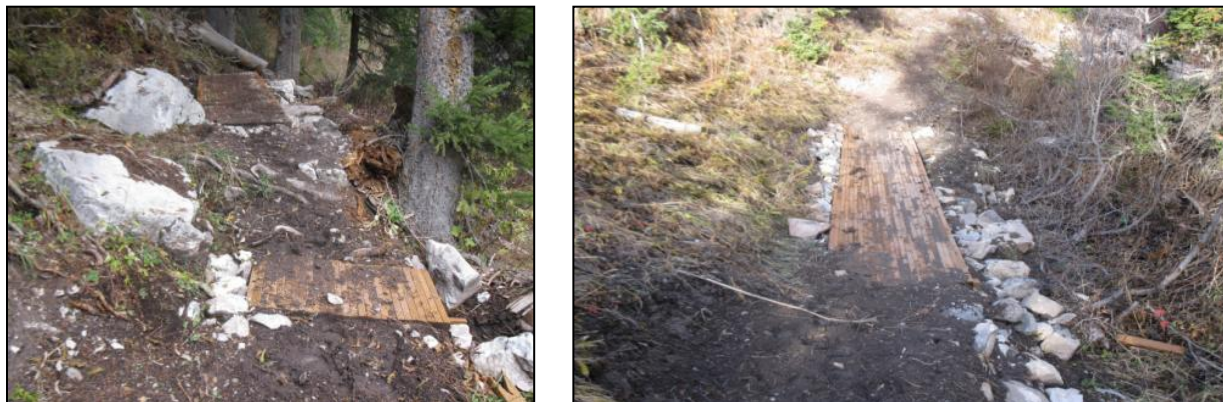
**East Fork Trail (#160):** The trail was reconstructed in 2008. In 2009, the Forest reduced impacts to several wet areas along the trail route by bridging or rerouting the trail to avoid impacts where practicable. More bridges were installed to span boggy areas and channels. Rocks were used to support the structures (Figure 28).

**Figure 28. East Fork Trail before (left) and after (right) reconstruction.**

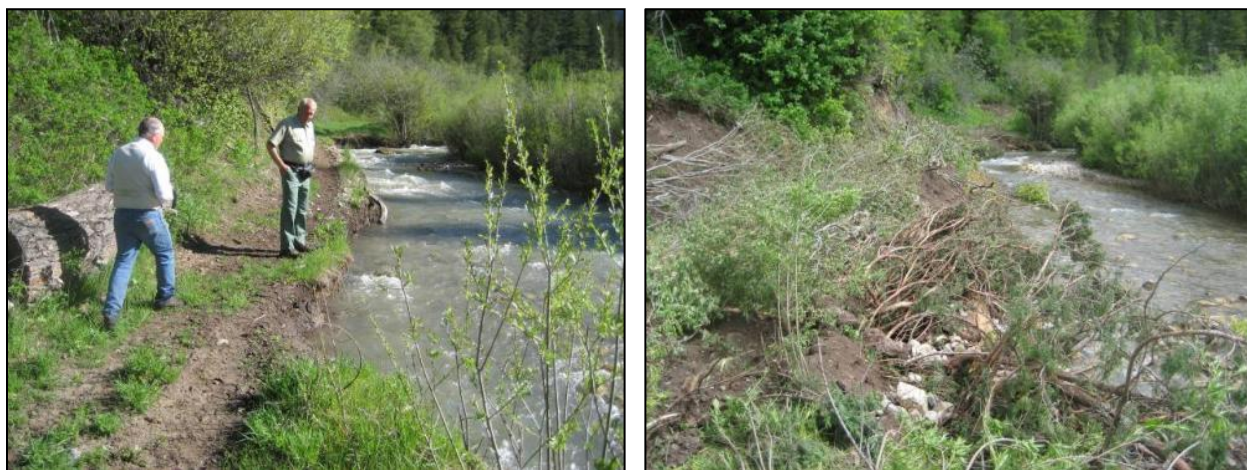
The Forest relocated the trail onto a bench above the existing trail and further from Rainey Creek. The relocation created approximately 680 feet of new trail and closed 160 feet of old trail in the riparian area. The old trail was closed and rehabilitated (Figure 29 and Figure 30). The project was funded with RAC funds.

**Figure 29. Before trail reroute (left) and after reroute and streambank stabilization (right).**

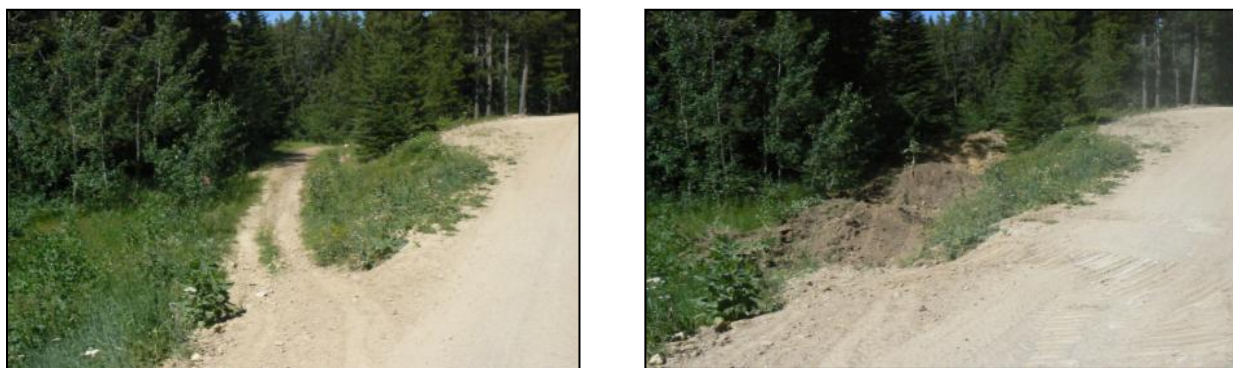
**Bigholes Road and Trail Closures:** This project included road and trail closures of spur routes along Bigholes Road (218) (located in both the Palisades and Teton River subbasins). Approximately 40 miles of nonsystem roads and trails were closed. The Forest road crew treated roads using heavy machinery. District Wildlife Biologist Bud Alford coordinated the closure effort. In most cases, the entire length of road or trail was obliterated (Figure 31). On a few roads and trails only sections of the route were closed. The areas left open were determined to be essential for livestock management to provide cattle access between the grazing units.

**Figure 31. Before (left) and after (right) obliteration.**

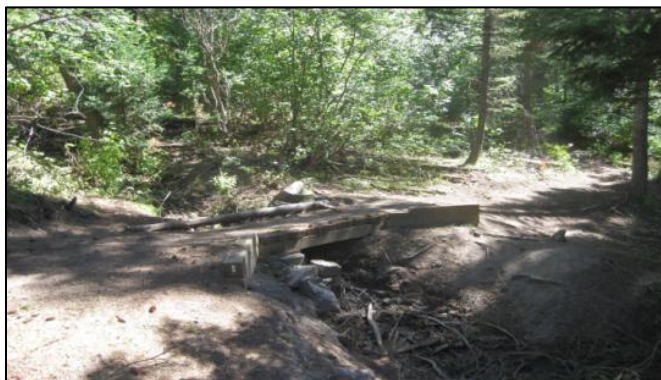
**South Fork Fall Creek Trail:** The Forest partnered with IDPR, the Idaho Falls Trail Machine Association, and the RAC to relocate 0.5 miles of the South Fork Fall Creek Trail (#030). Steep sections were becoming entrenched due to motorcycle use during wet periods. Three bog bridges were constructed to avoid crossing wetland areas (Figure 32).

**Figure 32. New bridge on the South Fork Fall Creek Trail.**

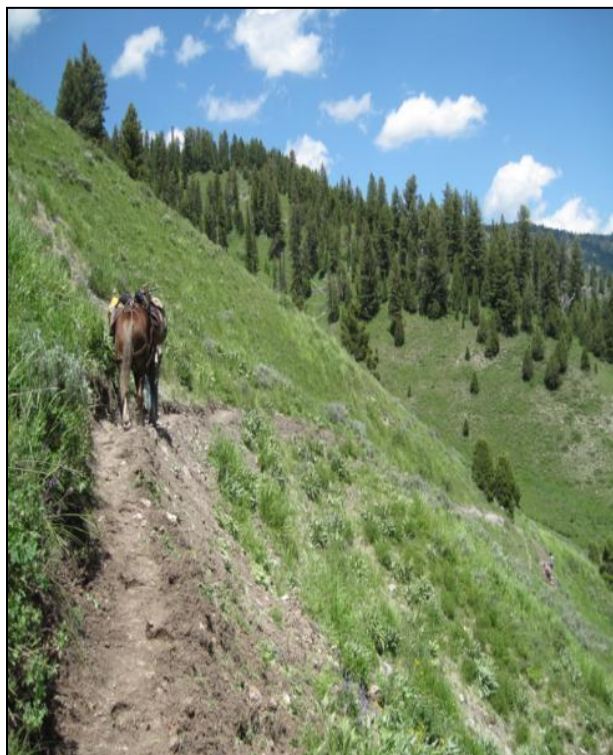
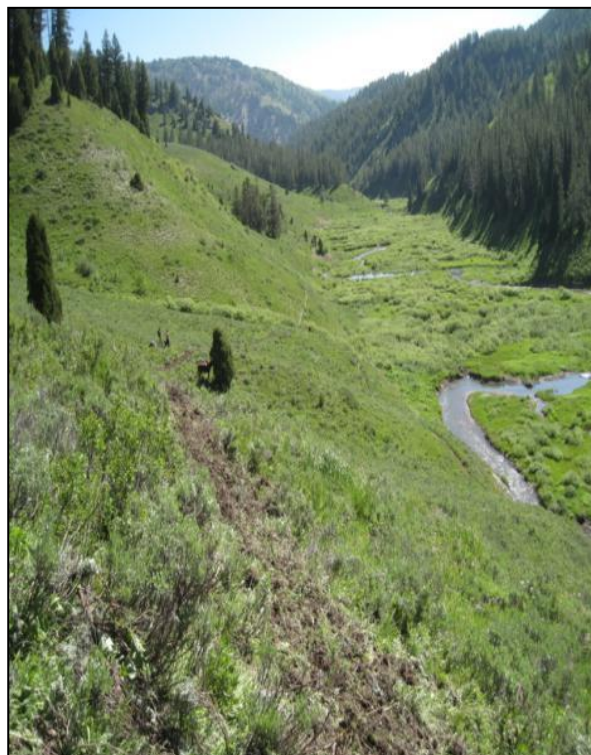
**South Bear Creek Trail:** The Forest used funds from IDPR to reroute 2.5 miles of South Bear Creek Trail (#048). The purpose of this project was to improve the stream and riparian conditions by moving the trail from the riparian area to upland locations where possible (Figure 33). Recent beaver activity had compounded the trail situation, which was poorly located originally. Explosives and draft horses pulling trail plows helped the trail crew complete this project.

**Figure 33. Before (left) and after (right) trail rehabilitation.**

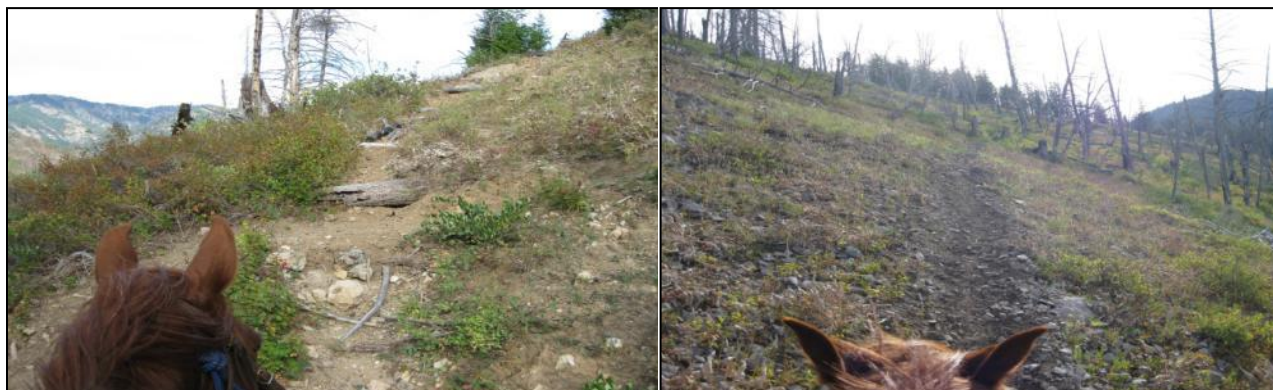
The original trail has been watered barred and blocked off. The new trail switch-backs up the hill.

**Figure 34. Before (left) and after (right) trail reconstruction.**

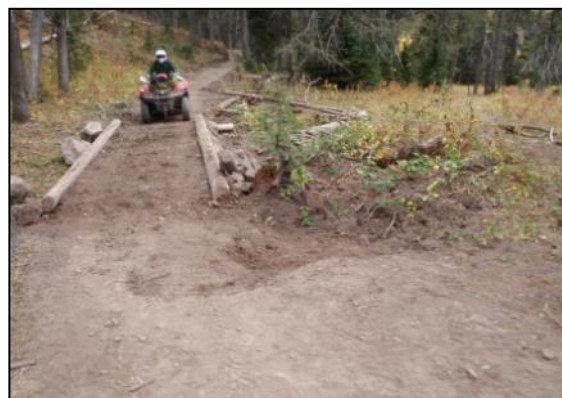
**Figure 35. Trail construction.**

**Looking Glass to Pine Creek Pass Trail (#077) and the Red Creek Bridge:** The IDPR Trail Cat Program assisted in the maintenance of 2.7 miles of trail. The trail crew identified locations to construct rolling dips and worked to armor numerous stream crossings in an effort to minimize the impact of off-highway vehicle recreation. They also completed basic maintenance tasks such as widening the trail corridor to allow for ATV traffic and decommissioning user-created routes and switchback cuts, which cropped up only a year after the initial trail construction (Figure 35).

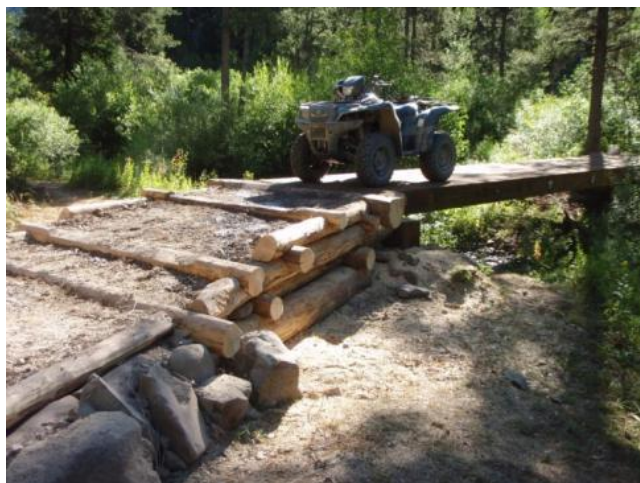
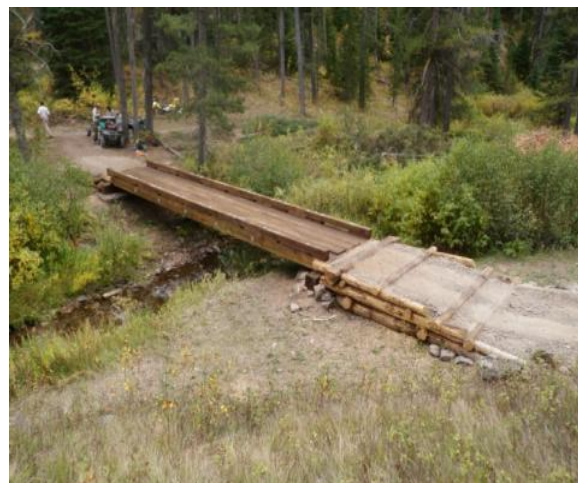
The Red Creek Bridge was also constructed on the trail. Construction of this bridge is one of the primary accomplishments of the 2010 Teton Basin trail crew (Figure 36).

**Figure 36. Red Creek Bridge Construction.**

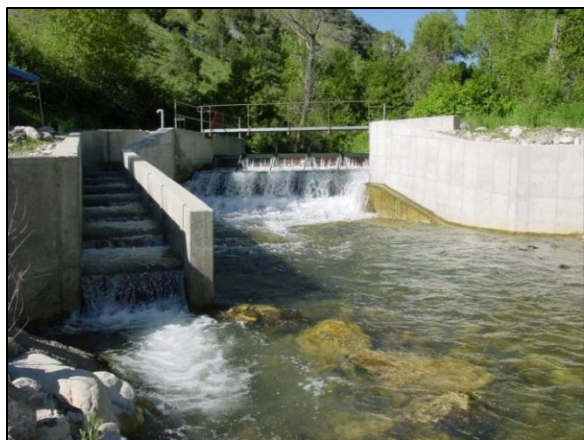
Figure 37. Burns Creek fish weir.

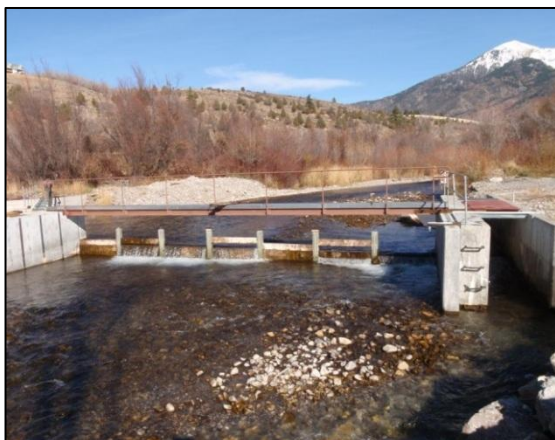
Figure 38. Palisades Creek fish weir.

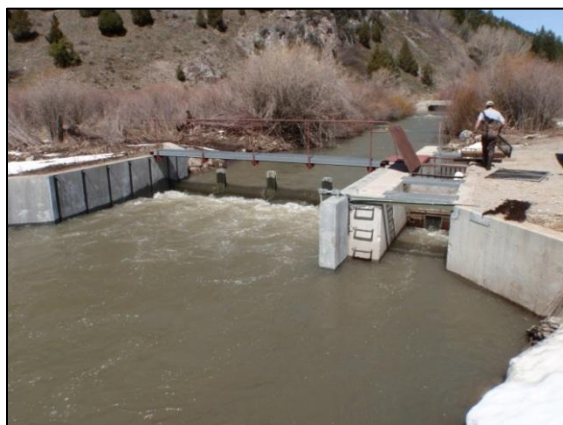
Figure 39. Pine Creek fish weir.

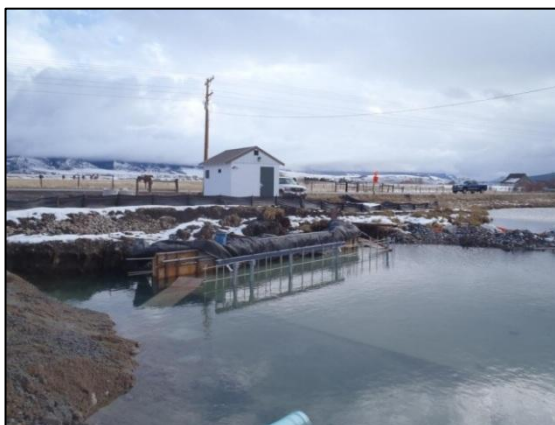
Figure 40. Rainey Creek fish weir.

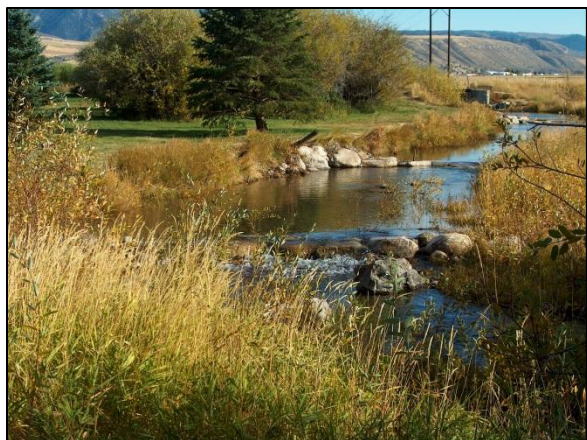
Figure 41. Rainey Creek restoration.

Once fish passage is fully restored, TU will work with a number of private landowners to implement offsite watering for cattle, riparian fencing and revegetation components, water efficiency measures like piping or lining ditches, and a number of bank stabilization measures to complete the overall restoration of Rainey Creek. Figure 41 through Figure 44 show pictures of channel modification and restoration on Rainey Creek.

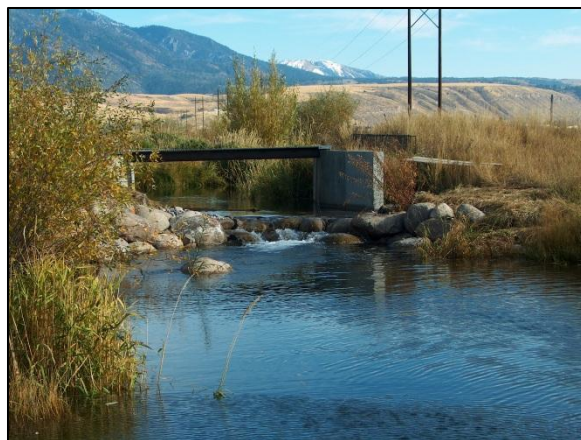
Figure 42. Rainey Creek diversion.

TU had fish screens custom built for the two bottom diversions. Because the screen material has to meet a certain specification criteria and will need to be fabricated, TU didn't expect to get these installed until 2009. TU is also fabricating an aluminum Alaskan steep pass ladder system for one of the diversions and a more basic ladder system for the other; both are custom builds.

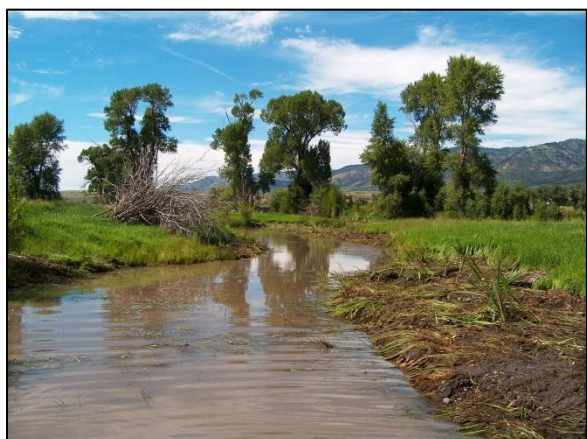
Figure 43. Rainey Creek channel modification.

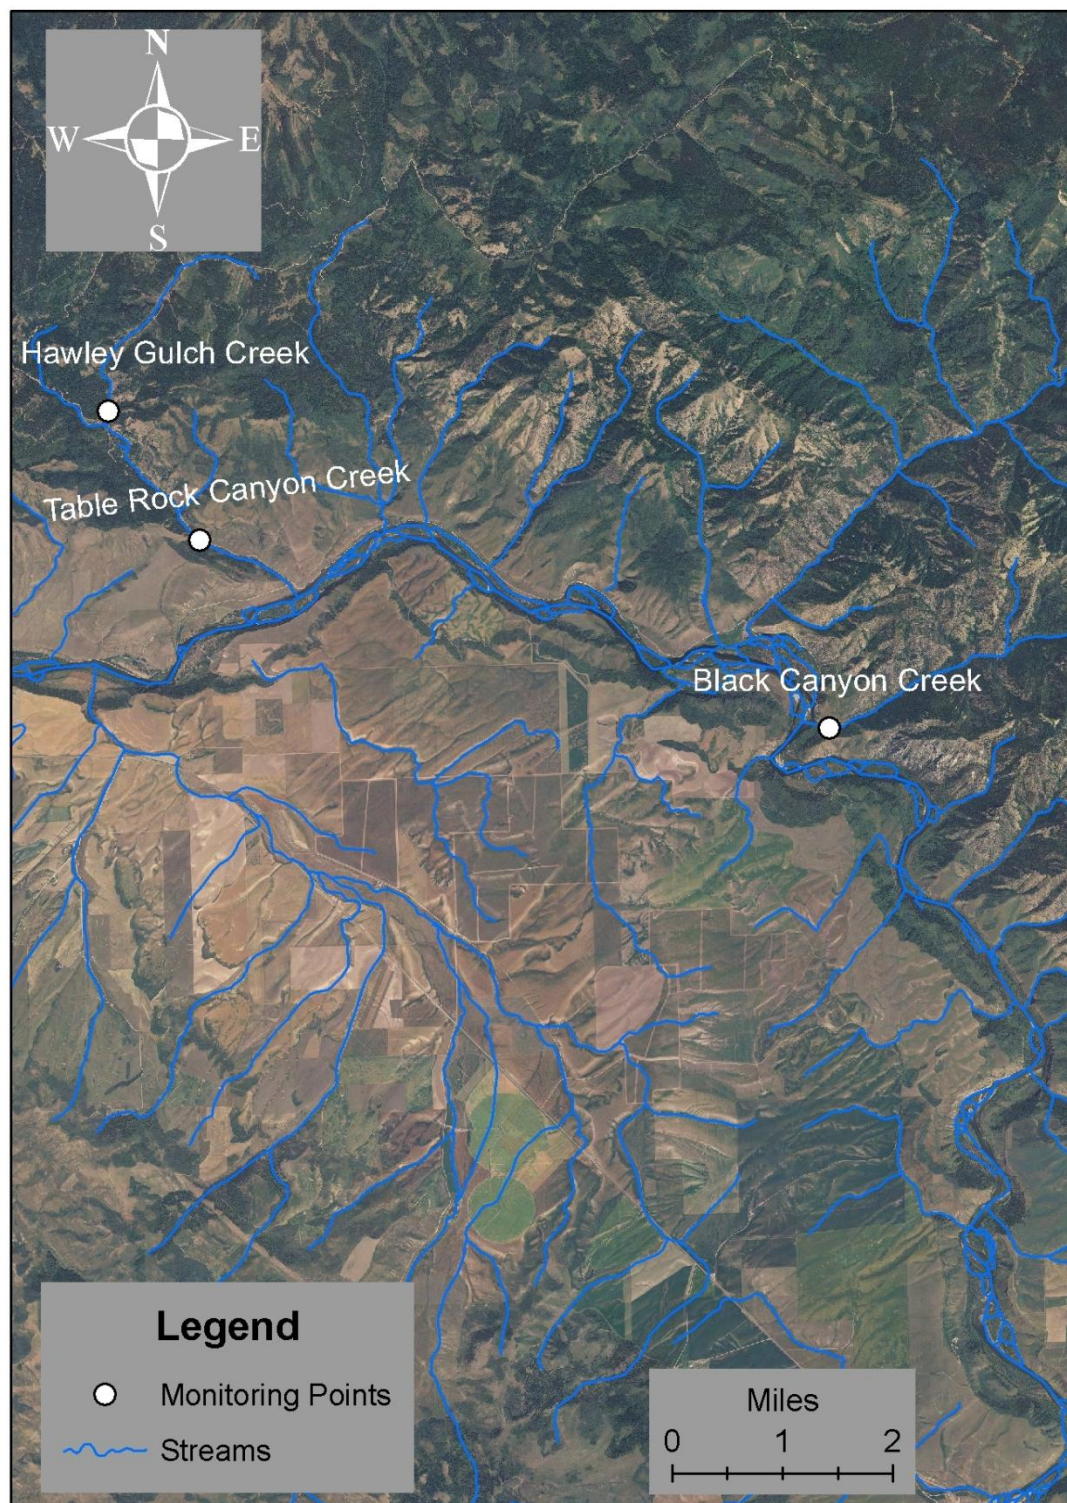
**Figure 47. Sediment monitoring points on Hawley Gulch Creek, Table Rock Canyon Creek, and Black Canyon Creek.**
